Title: Mallik Gas Hydrate Production Research Program
Weekly Science Report #2
January 29 - February 4, 2008

MALLIK GAS HYDRATE PRODUCTION RESEARCH PROGRAM

WEEKLY SCIENCE REPORT #2

JANUARY 29-FEBRUARY 4, 2008

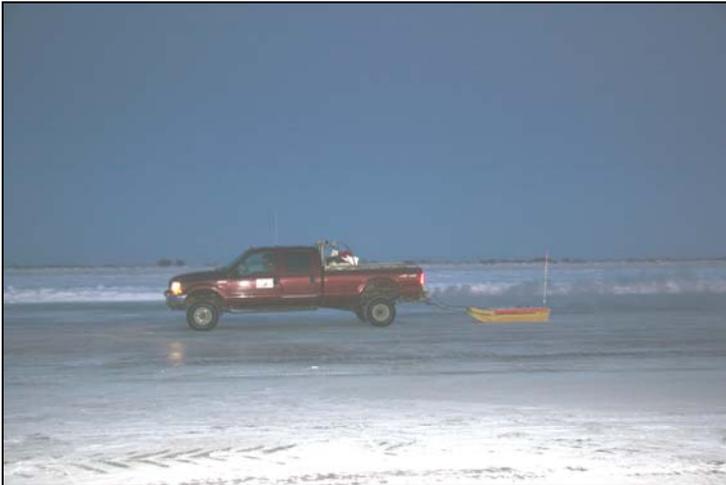
Ground probing radar is towed behind a Grubens truck to profile ice thickness before moving heavy loads to Mallik. While the ice was generally >1 m for most of the channel and sea ice areas, there was a short section with only 70 cm of ice.

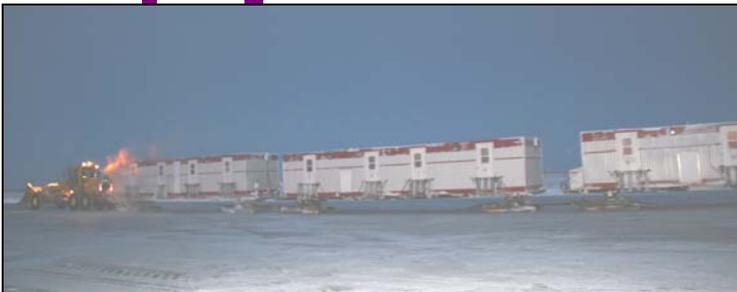
Considerable excitement on the radios as our sleigh camp is moved to Mallik. The 34 man camp was moved from Tuk to Mallik in five sections with more than 20 personnel coordinating the 15hr move.

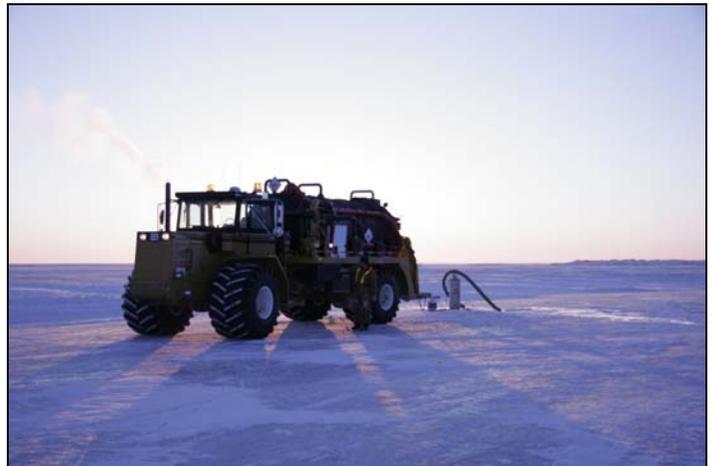
All terrain vehicle called a Gator working to spread water on lease.

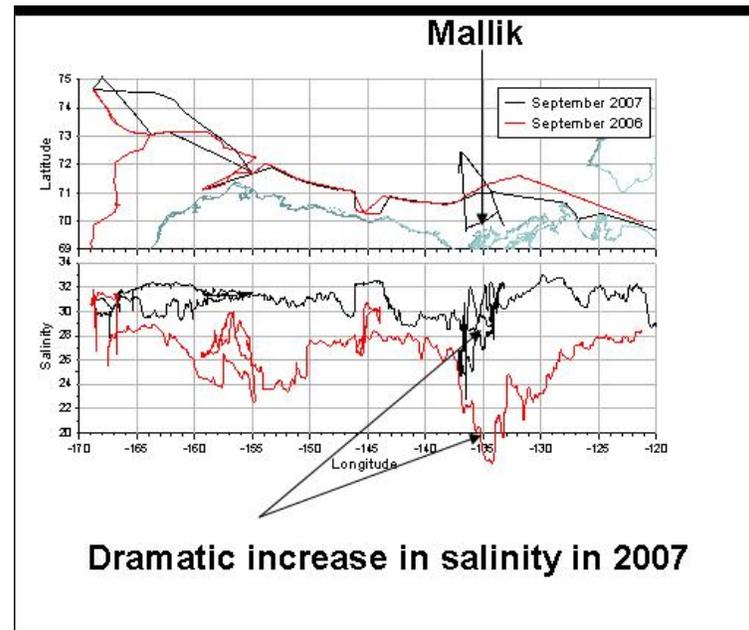
Figure courtesy of Humfrey Melling showing oceanographic data between Amundsen Gulf and the Chukchi Sea. Ship's latitude is plotted in the upper frame and near-surface salinity in the lower frame; the abscissa is longitude. Data are shown for both 2006 (red) and 2007 (black) along similar ship tracks at the same time of year. The ship followed the 1000-m isobath for much of the distance in both years.

It is all explained (well part of the story at least) in the plot below which shows the results of two research cruises Humfrey led in 2006 and 2007. The top map shows the cruise tracks for the Coastguard vessel Laurier, and the lower plot is a record of salinity of the sea water measured en route. The Steric effect is caused by changes in density of the ocean water affecting sea level. In this case Humfrey has recorded a significant change in salinity of the deep waters of the Beaufort Sea in the vicinity of Mallik. Normally because of the influx of fresh water from the Mackenzie River, salinities in this area are quite low (20 ppt observed in 2006), however in 2007 highly saline waters were dominant. Humfrey suggests this change in salinity and therefore density of the water column would naturally result in lower sea level as we have observed. Humfrey continues to study the climate and oceanographic factors influencing this salinity change with early insights suggesting that prolonged easterly winds experienced in this part of the Arctic for much of 2007 were a contributing factor.
