**Title:** Mallik Gas Hydrate Production Research Program  
Weekly Science Report #6  
February 25 – March 3, 2008

# MALLIK GAS HYDRATE PRODUCTION RESEARCH PROGRAM

## WEEKLY SCIENCE REPORT #6

FEBRUARY 25- MARCH 3, 2008

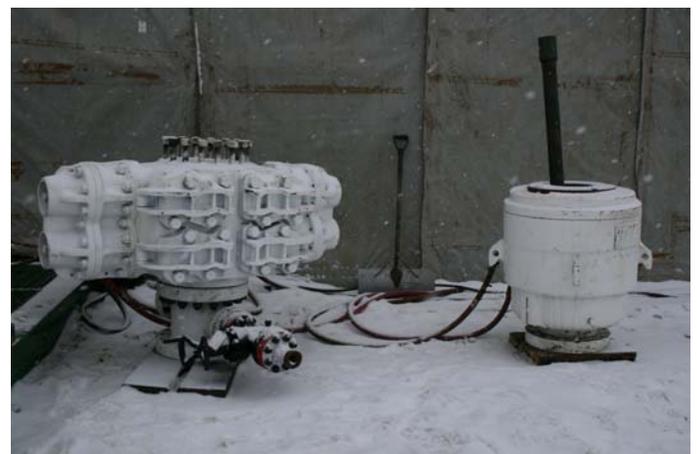
*The Achilles heel of week 6- The BOP components prior to rigging up. The annular on the right and the rams on the left are mounted on the well casing one on top of the other. Both function to provide isolation from the well pressures down hole. Both must function to conduct well operations.*

Whoa.. you say, what could happen in a week?.. Well those on this distribution list who don't get the daily completion report can perhaps have a close look at the February 28 and March 2 reports provided here. To help in the interrogation, highlighted in yellow is the type of problem we have encountered. The challenge of weather is evident as is the challenge of keeping equipment running. The missing factor that has bit us in the proverbial rear end this week, is the absence of a bit of luck. Simply put, our Blow Out Preventer (BOP) has been our Achilles heel. This is one piece of oil field equipment that does not have a confusing name like 'dog nut' (by the way we did have trouble with the dog nut too, but this is a longer story), as anyone can imagine the BOP is a piece of equipment that is critical to any completion operation. It is our primary line of security in undertaking well operations. Cleaning up the well, running our completion assembly, testing.. even just abandoning the well cannot proceed without a fully functioning BOP. Unfortunately as detailed in the completion reports the BOP has been causing problems all week. Worse as of 24:00hrs on March 3<sup>rd</sup>, the pipe rams on the BOP are not functioning as we are having problems with our accumulator. While most of our equipment on site has back ups, it is not normal to have two BOPs on a job like ours as they are generally very reliable pieces of equipment. Luck has not been with us and we are now on hold awaiting a fix..

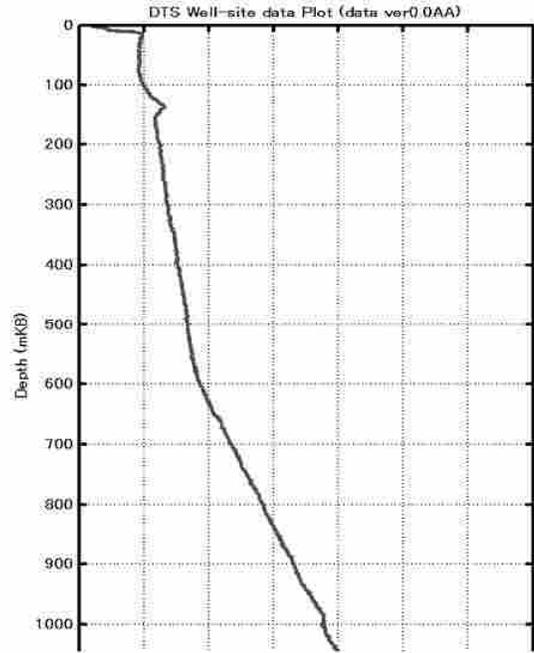
The baseline temperature profile reveals the typical temperature curve in the Mackenzie delta: the temperature curve increases to 0 degC in the thick permafrost layer and just below 600m depth the curve kicks off according to the regional geothermal gradient.

Thanks to IPM support, an early start of the DTS measurement allowed the SKK monitoring team to acquire with sufficient accuracy the temperature profile of the formation along 2L-38 Well casing from surface. The profile was acquired before the 2L-38 well was touched by operations, to reveal the downhole temperature after a year from last winter re-entry has past. Several calibration points were set to improve the accuracy of the measurement. At the surface, temperature readings from the optical sensing fiber were compared to calibrated resistance temperature sensors. Daily fluctuations in the surface temperature caused by the strong wind were observed in the initial data. Modeling carried out by the temperature physicist Naoki Sakiyama revealed that such effect could be reduced by covering the surface cables with a meter of packed snow. The whole SKK team participated in the task by shoveling and packing hard snow for a few hours.
