Title: Mallik Gas Hydrate Production Research Program
Weekly Science Report #7
March 4 – 10, 2008

MALLIK GAS HYDRATE PRODUCTION RESEARCH PROGRAM

WEEKLY SCIENCE REPORT #7

MARCH 4 - 10 , 2008

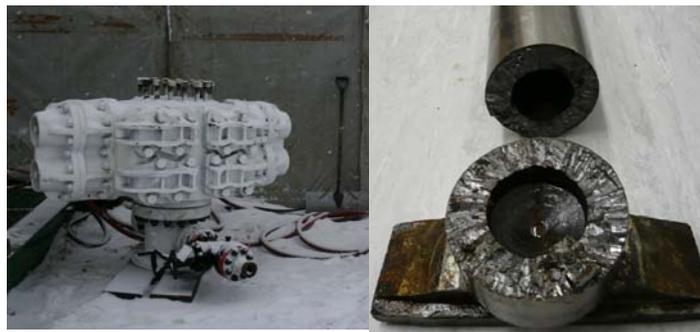
The cause of the BOP problem encountered in week 6 was a broken pipe ram

Last week ended with the Blow Out Preventor (BOP) causing us problems and actually putting a stop to well operations. This week began with trouble shooting as two BOP technicians were flown in from Edmonton (one on a special charter from Yellowknife). The cause of the problem was quickly identified as a sheared pipe ram. Incredible but true!@@!##!

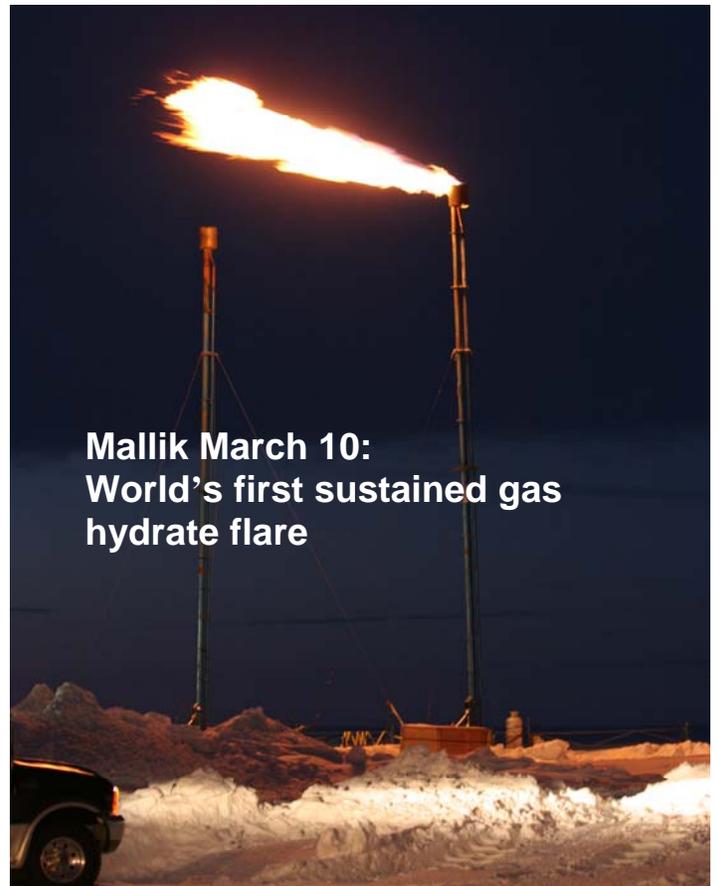
The following photo I think explains the nuts and bolts of where we are at. As I write at 12:00hs on the 11th.. we have had one darn amazing and beautiful gas hydrate test ongoing for more than 15 hrs! After more than four years of planning, thanks to the effort of a team of well over a hundred managers, scientists, engineers, oil field workers, cooks and bottle washers we have made history as frankly speaking this has not been done before! And just to tease you a bit.. the learning's to date are HUGE.

Gerardo Serrano took this photo at 3:00am.. Gerardo I owe you a beer for this!.. pledge by SRD

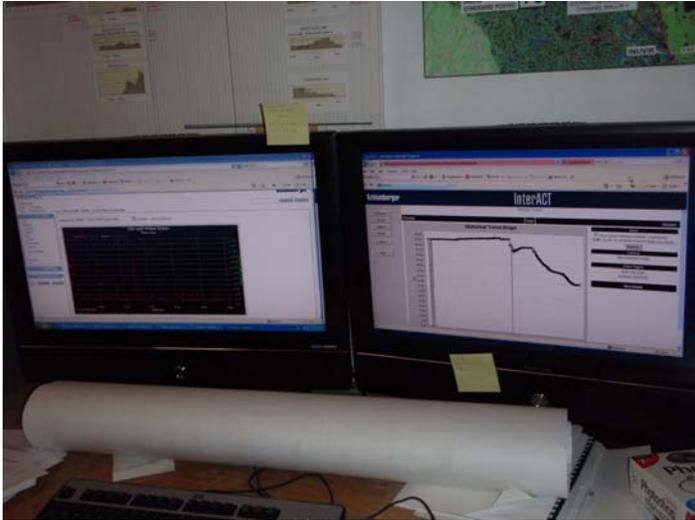
Data streaming in real time to Inuvik from Mallik test.. plot on right shows the bottom hole flowing pressure stabilizing at about 7.5MPa (dark line on screen). The flow data on the left screen is top secret!
